# **EVALUATION OF RISK AND POSSIBLE MITIGATION SCHEMES FOR PREVIOUSLY UNIDENTIFIED HAZARDS**

William Linzey, Micah McCutchan, and Michael Traskos  
Lectromechanical Design Company

## **Preface**

In April 2004, the NASA Engineering and Safety Center (NESC) was commissioned by NASA's Chief Safety and Mission Assurance (S&MA) Officer to review and render a technical opinion on the probability of a catastrophic failure related to this scenario: The Space Shuttle Program (SSP) recognized a zero-fault-tolerant design related to an inadvertent firing of the primary reaction control system (RCS) jets on the Orbiter during mated operations with the International Space Station (ISS). It was determined that an un-commanded firing of an RCS jet could cause serious damage or loss of both the SSP Orbiter and the ISS. Several scenarios were suggested in which an un-commanded firing of the RCS jet is possible [1]. These scenarios include an arc track event in the 28-volt heater circuits that could result in a wire-to-wire short to the adjacent reaction control jet wire. In this worst-case scenario, enough current and power could be applied to activate the reaction control jet valves and fire a

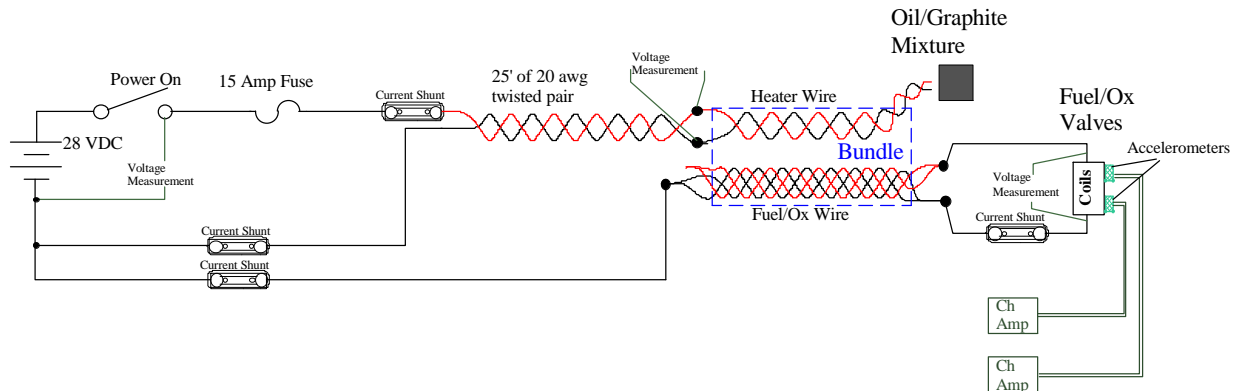
**Figure 4a. Harness Configuration 1: 1 Heater Circuit, Fuel/Ox = Unshielded Twisted Quad**

Harness configuration 1 (Figure 4a) was the simplest configuration, with only one heater circuit. This configuration was used in Tests 1 through 5 with unprotected twisted quad for the fuel/ox wires. This setup corresponds to the configuration that exists in some locations on the Orbiter.

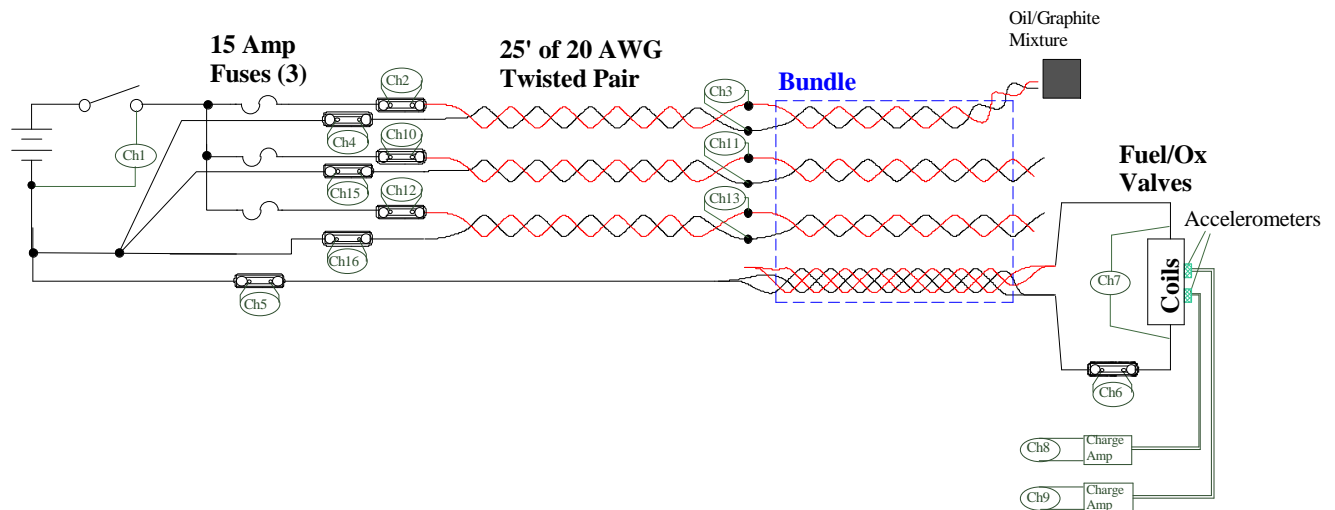
**Figure 4b. Harness Configuration 1: 3 Heater Circuits, Fuel/Ox = Unshielded Twisted Quad**

Harness configuration 1 with three heater circuits (Figure 4b) was used in Tests 5 through 10 for the unprotected twisted quad. This series of tests represents the configuration that presently exists in some locations on the Orbiter. Tests performed in this group determined whether the present Orbiter configuration would allow enough voltage and current to be transferred to the fuel/ox wires to cause coil activation.

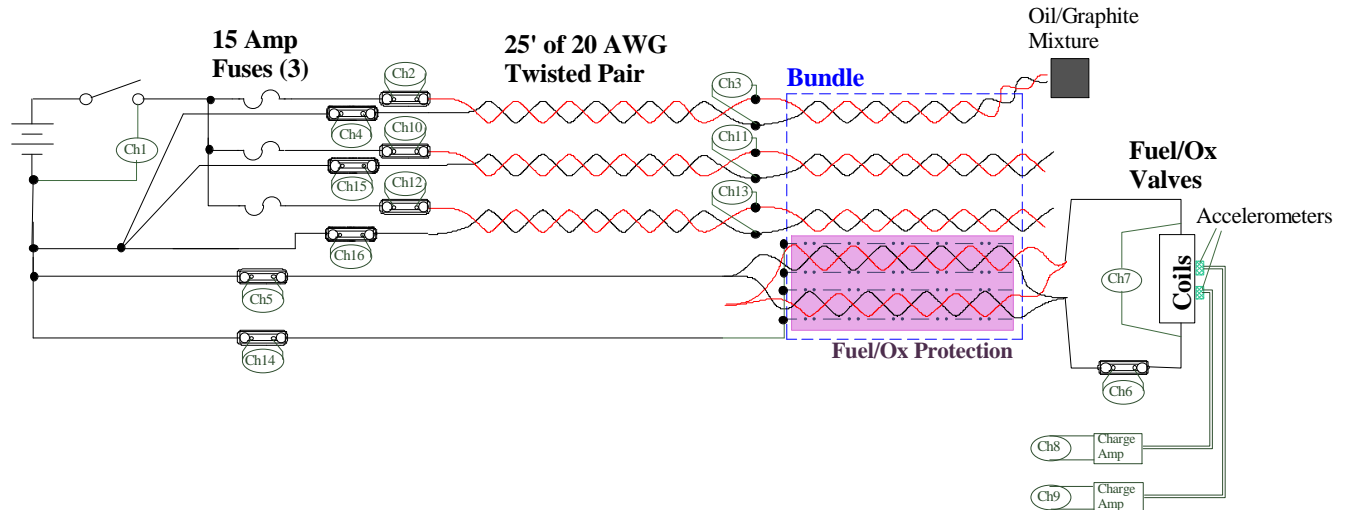
**Figure 4c. Harness Configurations 2 and 3: 3 Heater Circuits, Fuel/Ox = Shielded Twisted Pair**

Harness configurations 2 and 3, with three heater circuits (Figure 4c), were used in Tests 11 through 75. This series of tests used two twisted shielded pairs for the fuel/ox wires, and included five tests for each of the protection schemes identified in Table 2. Note that the purple box highlights the fuel/ox wires. It should be recognized that each twisted shielded pair had its own metal shield and that one shield does not protect both twisted pairs of fuel/ox wire (see Figures 1 and 2).

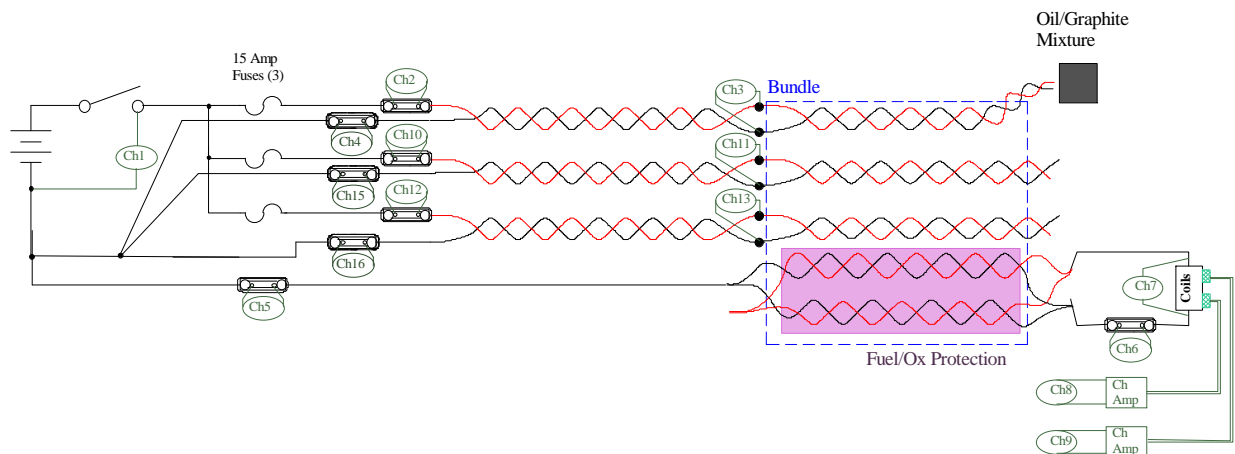
**Figure 4d. Harness Configuration 4: 3 Heater Circuits, Fuel/Ox = 2 Unshielded Twisted Pairs**

Harness configuration 4 (Figure 4d) was used in Tests 76 through 145. This configuration was essentially the same as configurations 2 and 3, with unshielded twisted pairs replacing the shielded twisted pairs for the fuel/ox wires. This test series included five specimens for each of the protection schemes identified in Table 1.
